**THE BRITISH BROADCASTING CORPORATION
ENGINEERING DIVISION**

ACOUSTIC TESTS IN BROADCASTING HOUSE, MIXER SUITE 1A

Technological Report No. PH-2/1
UDC 534.861.1 1967/2

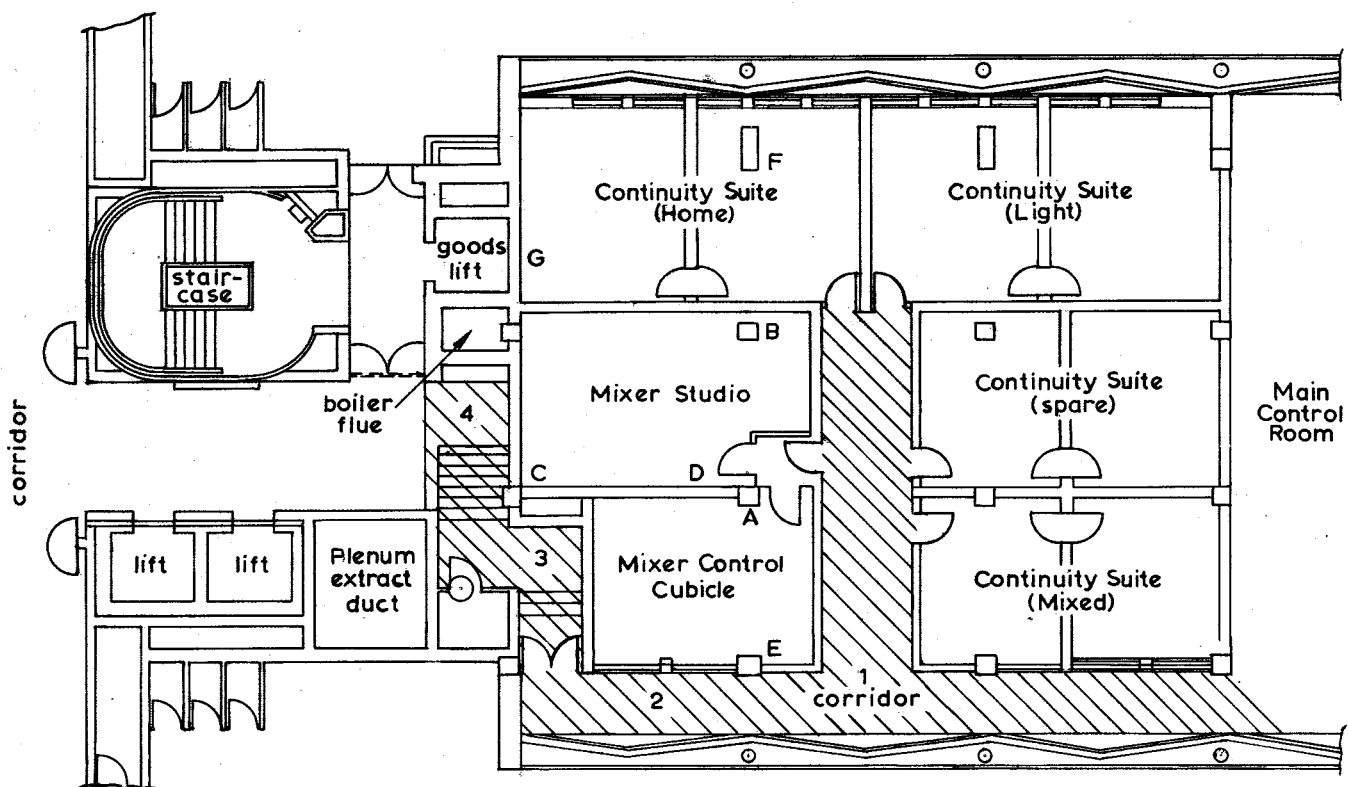
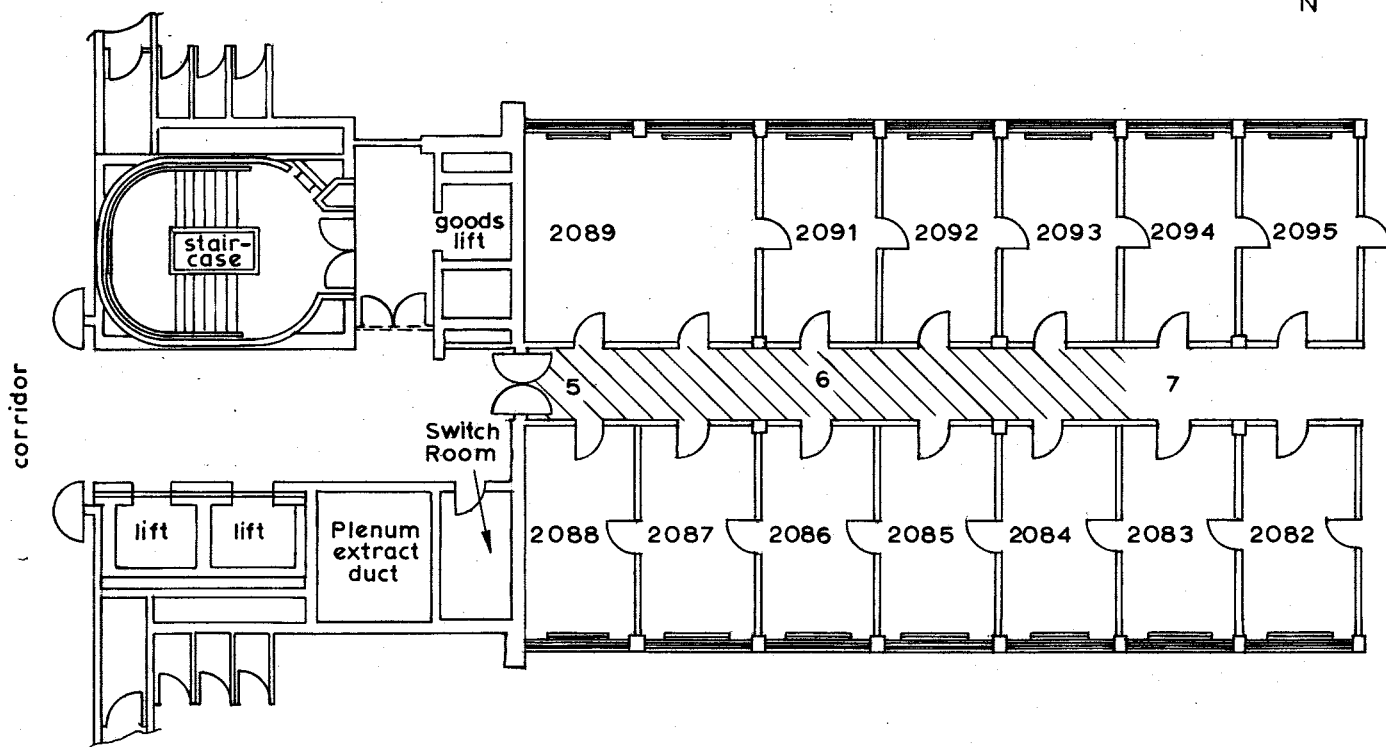
Fig.1 Broadcasting House extension. Plan view of part of 1st and 2nd floors.

The Mixer Suite 1A is situated adjacent to the Continuity Suites in the main control room area on the first floor of Broadcasting House Extension. Above this area on the second floor are offices opening from a central corridor which is immediately above the Mixer Studio. Adjacent to these areas on both floors are the personnel lifts, goods lifts, cleaner ducts and other service facilities. Complete plans of the area are shown in Fig. 1. The flooring of the corridors and stairs in these areas is of thermoplastic tiling on concrete.

programmes originating from Mixer 1A and possibly also from Continuity 1. The measurements obtained from hammer blows in office 2088 indicated that a simple solution to the problem would be the provision of carpeting or a similar resilient material in those parts of the corridor and staircase which are shown shaded in Fig. 1(a) and Fig. 1(b).

It is therefore recommended that some form of resilient floor covering should be provided in the above mentioned areas and this covering should be extended to the uncarpeted areas of rooms 2084 to 2093 inclusive.

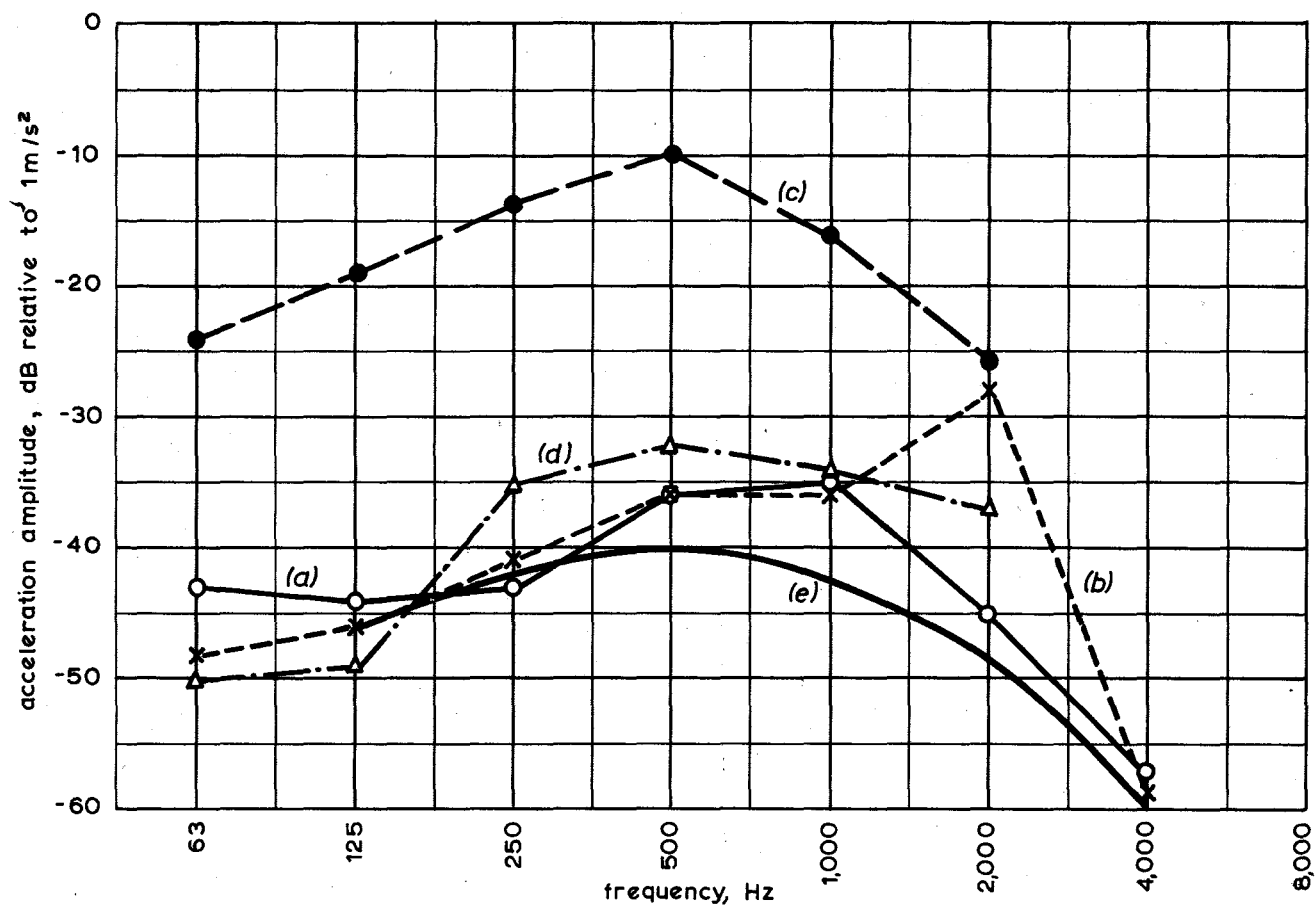
Fig.2 Acceleration amplitudes in Mixer 1A Studio. (Excitation position 5)

An accelerometer was attached to various points, marked A to G in Fig. 1(a), in the Mixer Suite and the adjacent Continuity Suite. The output of the accelerometer for several hammer blows at various positions in the corridors surrounding the Mixer Suite was recorded and subsequently analysed by means of a peak programme meter preceded by octave band-pass filters. Fig. 2 shows the acceleration amplitudes measured at various points within Mixer 1A studio for hammer blows at position 5 in the corridor above (see Fig. 1(b)). For three positions on the structure the acceleration levels generally exceed those found to be acceptable in the Bush House investigation. The results for position C which was on the wooden framing carrying the absorbing treatment within the Mixer Suite is very greatly in excess of the acceptable values.

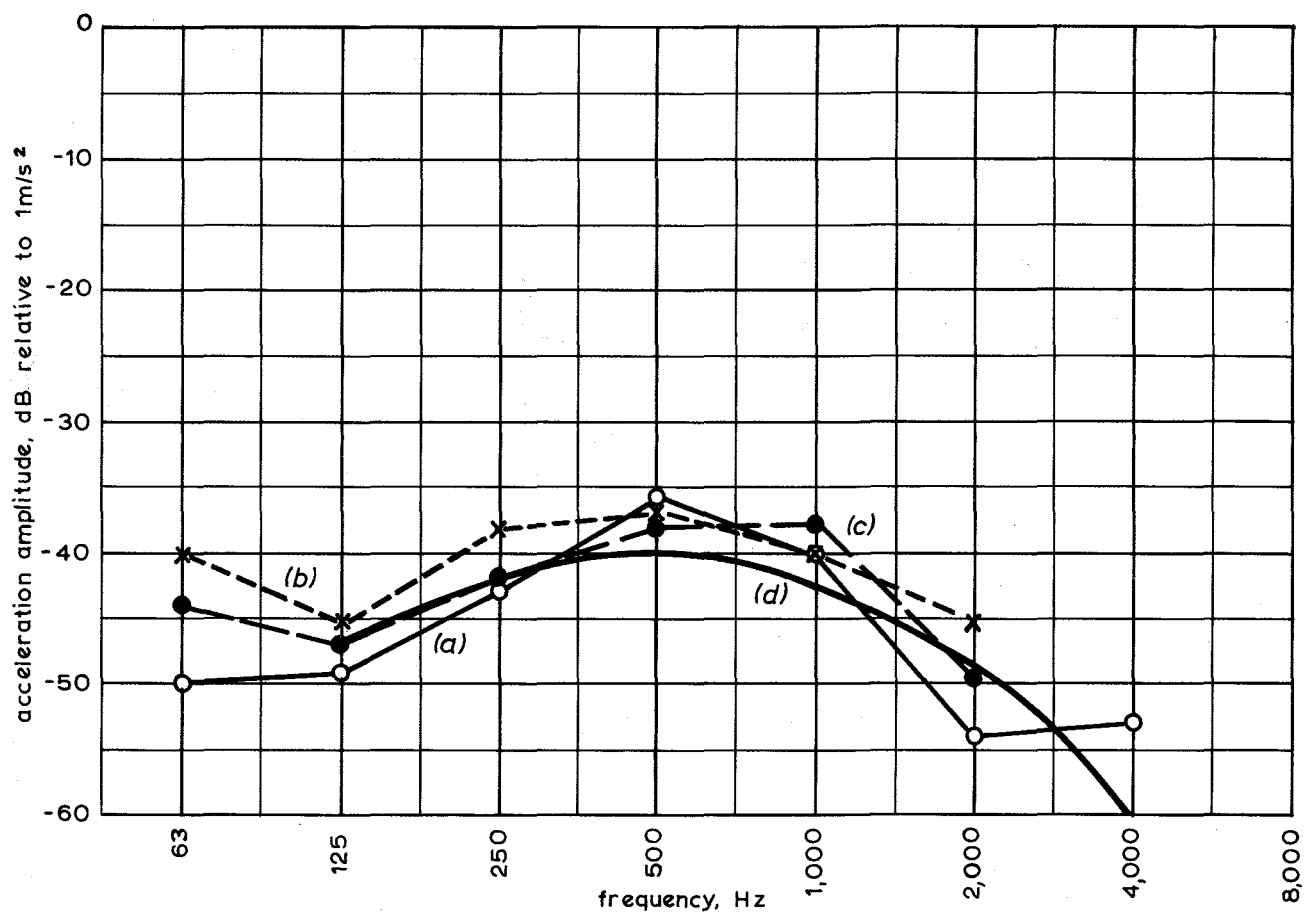
Fig.3 Acceleration amplitudes in areas adjacent to Mixer 1A Studio
(Excitation position 5)

Fig. 3 shows similar results for the Mixer 1A cubicle and for two accelerometer positions within Continuity 1 Suite. The results for these areas are only slightly in excess of the acceptable levels, and it seems improbable that complaints in these areas would arise from footfalls in the corridors above. Fig. 4 shows acceleration amplitudes measured in the Mixer Suite and the Continuity No. 1 Suite for hammer blows on the landing outside cubicle 1A (position 3 in Fig. 1(a)), and these levels in both the Mixer Studio and Continuity 1 studio, are such that interference with programme would appear to be inevitable in both areas. It is also likely that footsteps noise would be audible in the cubicles but would not constitute an interference with the work being carried out.

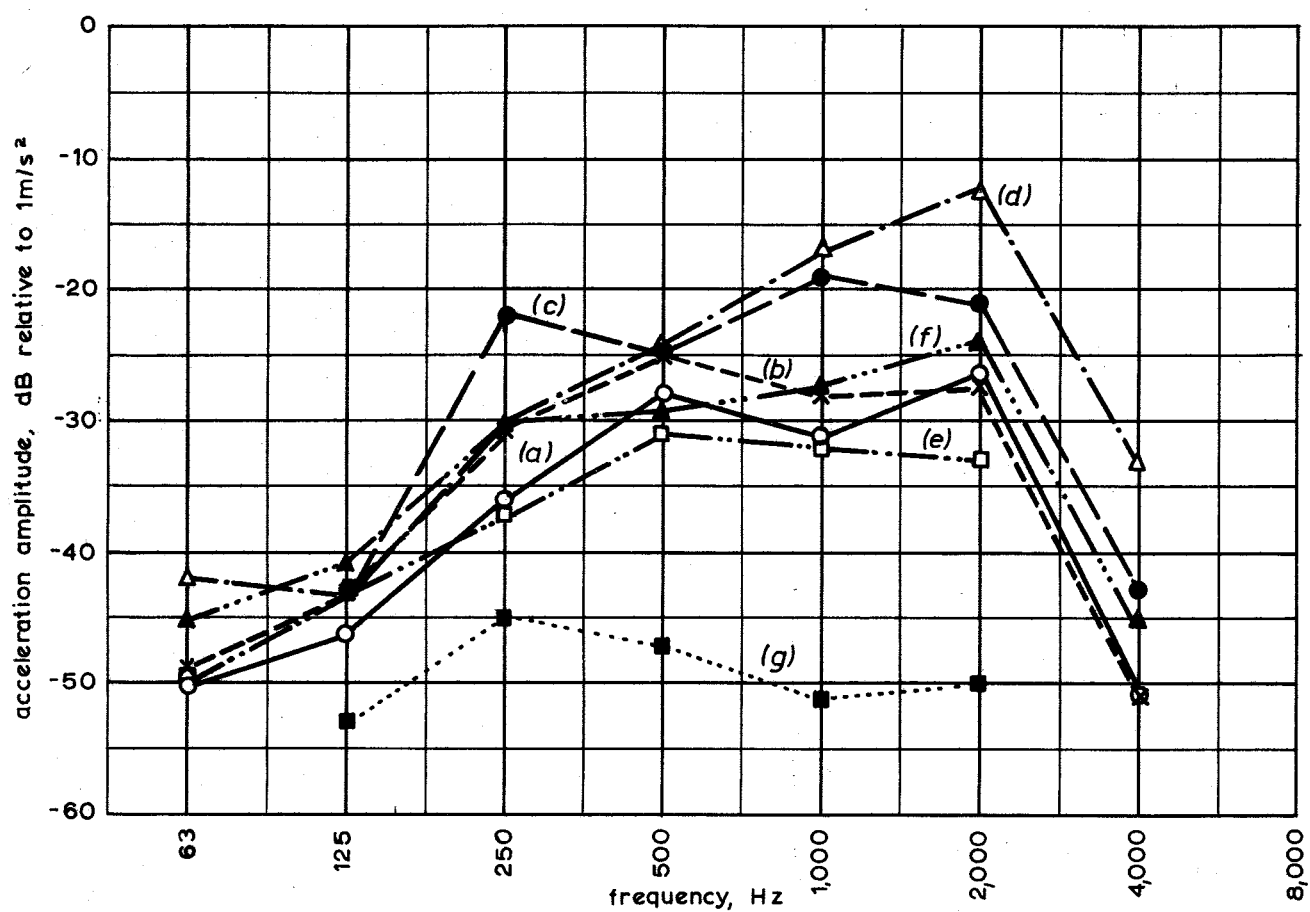
Fig. 5 Acceleration amplitudes on the floor of the microphone skirting in Mixer 1A Studio for excitation points 1 to 7 (Figs 1a and 1b)

(position D in Fig. 1(a)) were measured in conjunction with many different excitation positions in the corridors and staircases surrounding the Mixer Suite. The results in Fig. 5 are for six positions which gave levels in excess of the acceptable values and one position giving acceptable levels. Hammer blows at positions more distant than those shown gave levels well below the criterion curve.

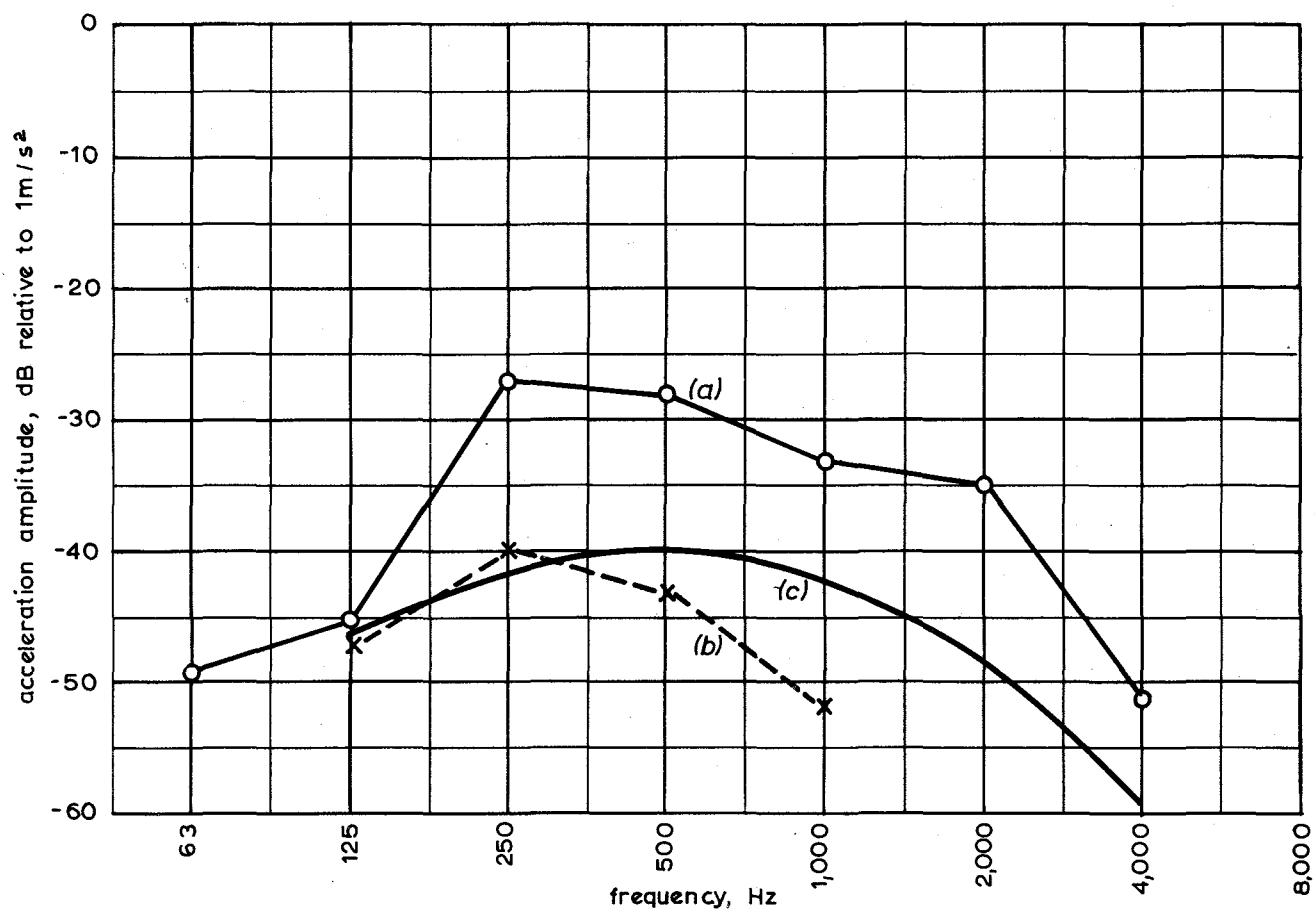
Fig.6 Acceleration amplitudes on the floor of the microphone skirting.
(Excitation - hammer blows in Room 2088)

Fig. 6 shows acceleration amplitudes measured on the floor slab of the Mixer Studio for two hammer blow positions in the office No. 2088 on the floor above. The measured values for curve (a) were for hammer blows direct on to the wood-block floor of the office while those shown for curve (b) were taken on the carpeted area immediately adjacent. It will be seen that the addition of carpeting is sufficient to reduce the vibration to acceptable levels.
